## OVERFLOWING TESTS AT THE POLISH DREDGDIKES RESEARCH DIKE – STABILITY OF THE DIKE SURFACE AGAINST EROSION

**Abstract.** In the project DredgDikes the different research dike embankments were tested with respect to overflowing water induced erosion. Therefore, flumes were installed on the land side embankments in which the effect of overflowing water on the vegetated surface was investigated. On the Polish DredgDikes research dike near Gdansk, Poland, two parallel flumes were installed and the surface of the dike made of different mixtures of ash, silt and sand as well as clay was tested both in vegetated and unvegetated state. The results showed that the grass sods placed on the dike embankment had a comparably low erosion stability, particularly if placed directly on the hardened ash/silt dike cover with better results if placed on a clay cover, while the ash/silt mixture showed a high erosion resistance without vegetation. This results in the recommendation to use a thicker vegetation layer on top of the ash composite dike if the vegetation shall account for the erosion resistance or else, that even if the grass cover is washed away, a very solid cover made of the ash composit

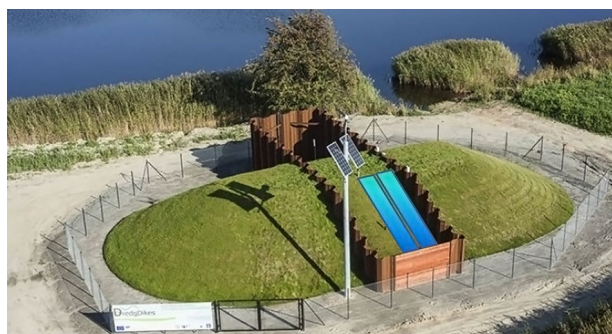
Fig. 3. Gdansk research dike with test section and location of flume 1 (right) and flume 2 (left)

The 3 m high research dike located in Wiślanka/Trzcińsko on the bank of Vistula River ca. 20 km outside the City of Gdańsk was completed in the summer of 2012 (Sikora, Ossowski 2013). It has a slope inclination of 1V:2H and a 3 m wide crest. The 4 m wide test segment of the 24 m long dike is separated by sheet pile walls to obtain two-dimensional plane conditions for seepage and overtopping tests with a controlled water level (Fig. 3).

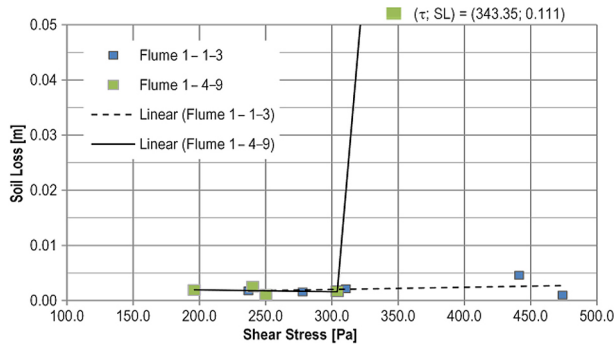
Fig. 10. Erosion rates flume 1 (vegetated); soil loss and shear stress, steep trend line = high erosion rate, focus on the upper (“1-3”) and lower (“4-9”) flume parts, September 2014

Figures 8, 10, 11 and 12 show the results of the vegetated slope while Figures 9, 13, 14 and 15 present the results for the unvegetated conditions, both for the whole flume length and separated into upper and lower section. The shear stress results were chosen to be presented here, since they provide good information regarding the erosion resistance. In addition, Figure 15 shows an example of the image documentation of the slope surface development in flume 1. Due to the scattered measurement results, the definition of a “best fit” trend line through the data points was not reasonable. Instead, a linear trend line was chosen for all charts to define the flume specific soil loss functions. A higher inclination of the trend line stands for a higher erosion rate.

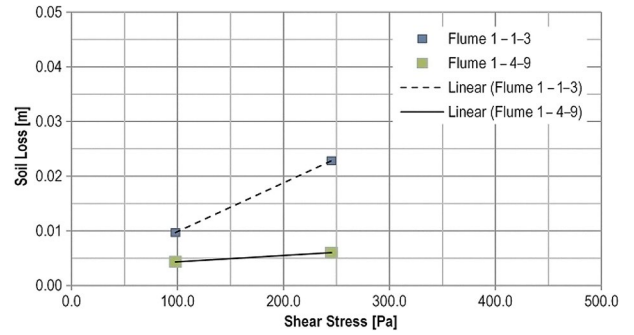
Fig. 13. Erosion rates flume 1 (unvegetated); soil loss and shear stress, steep trend line = high erosion rate, focus on the upper (“1-3”) and lower (“4-9”) flume parts, September 2014

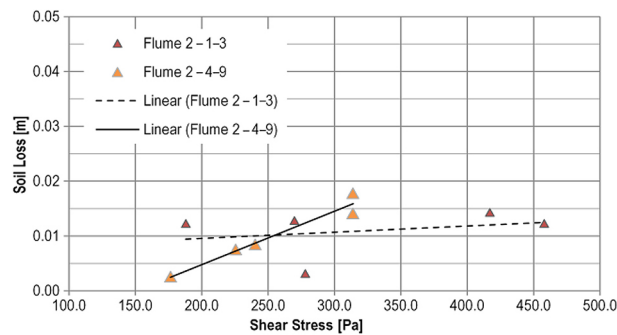
Fig. 11. Erosion rates flume 2 (vegetated); soil loss and shear stress, steep trend line = high erosion rate, focus on the upper (“1-3”) and lower (“4-9”) flume parts, September 2014

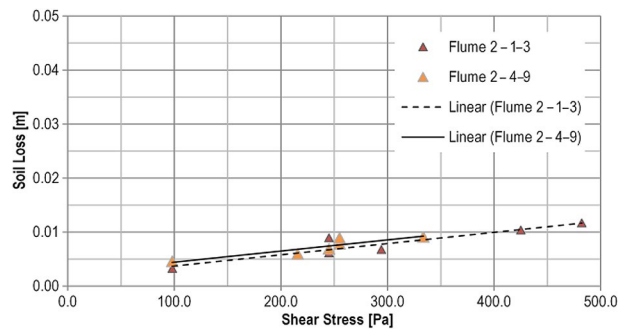
Fig. 14. Erosion rates flume 2 (unvegetated); soil loss and shear stress, steep trend line = high erosion rate, focus on the upper (“1-3”) and lower (“4-9”) flume parts, September 2014

only moderate. This is illustrated by the modest slope of the regression lines in Figures 9 and 14.

charge load. After the removal of the vegetation, the flat surfaces of both materials did not show a measurable difference (Fig. 14).

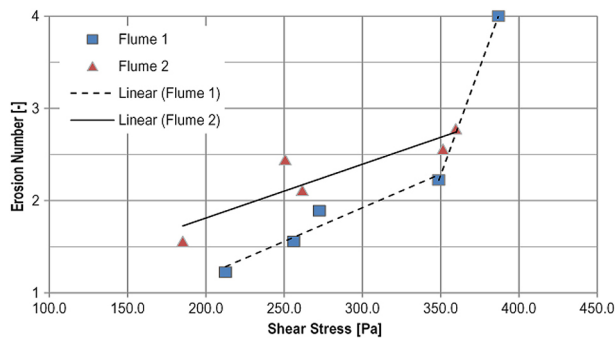
Fig. 12. Erosion numbers flumes 1 & 2 (vegetated); steep trend line = high erosion rate, Sept 2014

An important disadvantage of erosion measurements with a pin profiler is that the erosion is measured only at a few discrete (here: five) points in the upstream part of a test sections used to compute an average value for the whole test section. To overcome this drawback, every test section was additionally rated with the erosion numbers 1 to 4 before and after each flow event. Although there is no quantitative determination of soil loss, this method has the advantage that the condition of the whole surface can be described. The erosion numbers were then compared with the shear stresses for vegetated and unvegetated slope conditions (Figs 12, 15).

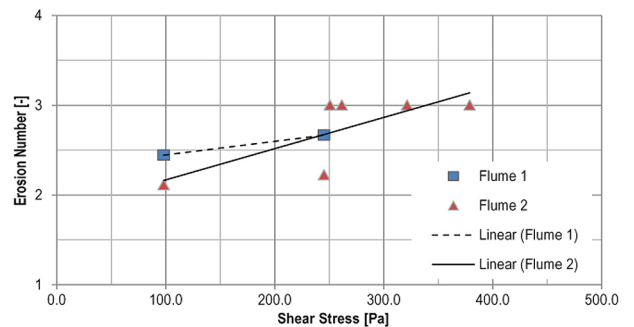
Fig. 15. Erosion numbers flumes 1 & 2 (unvegetated); steep trend line = high erosion rate, September 2014

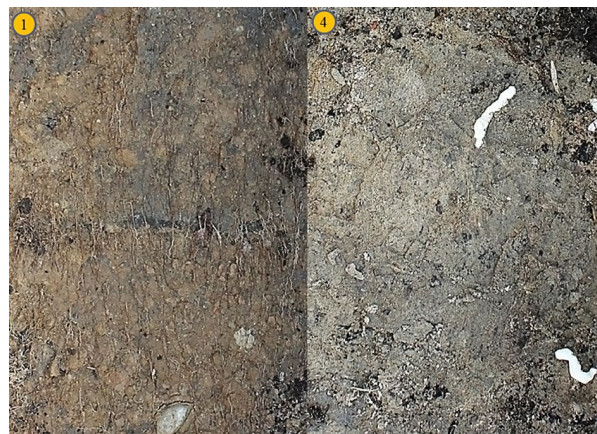
Fig. 16. Root penetration at the unvegetated slope surface. Depending on the subsoil the roots cling into the surface (clay layer, left) or almost not (ash/silt mixture, right). Flume 2, test sections 1 and 4, original unvegetated conditions

Another important issue is the use of rolled turf on the two different cover materials. The connection between the turf and the clay was considerably better (due to roots penetrating the clay and the high adhesion between clay and top soil/turf) than that between turf and ash composite. No roots penetrated the ash composite (Fig. 16). Thus it is not recommended to use rolled turf for dike cover greening if ash composites are used in the dike cover layer. The different cover materials also resulted in a difference in vegetation development due to medium (clay) and no (ash composite) water supply from below. Particularly on the southern embankment the turf failed during the first summer because the thin layer of top soil could not support the turf (not even on top of the clay). Therefore, a top soil layer of 20–40 cm thickness is recommended when installing an ash composite as dike cover material. For this, the benching technique is recommended to stabilise the top soil on the compacted ash composite or else to use a geosynthetic erosion control mat to reinforce the top soil on the embankment.

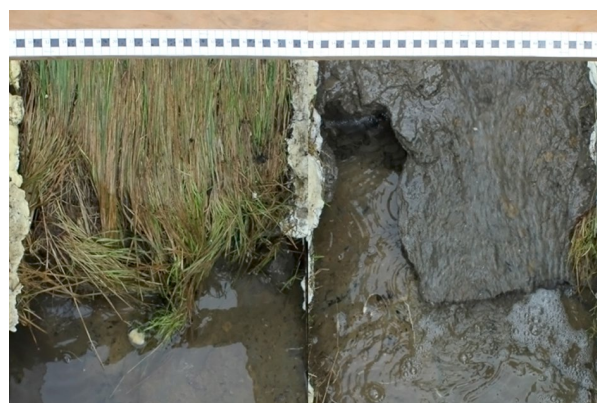
Fig. 17. Dike toe. Clay liner underneath the dike, slip line between the ash/silt dike cover and the clay base. Test section 9 of flume 1 (right) and flume 2 (left) after the 5<sup>th</sup> TD (veg.)

A further important aspect is the underground condition at the dike toe. In case of the research dike the connection between the compacted clay liner that served as an impermeable ground and the ash/silt body/cover material was weak and thus a slip line developed quickly during the overflowing test and the dike toe failed (Fig. 17). This may be mitigated by embedding the dike cross-section including the cover material into the ground or by using technical help such as geosynthetic erosion control mat or reinforcement product.
