RESTORATION TECHNIQUES FOR THE HERITAGE BUILDING / KIRKUK QISHLA AS A CASE STUDY

This research deals specifically and practically with restoring the Qishla building in Kirkuk as a restoration sample. Some parts of that building collapsed recently and the research aims to save that building by studying the techniques of restoring it using the materials and building techniques of the era the building was built in.

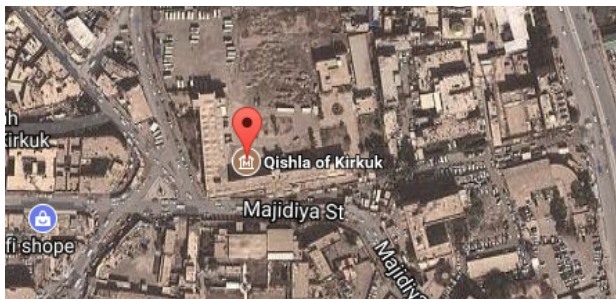
Figure 4. a) Shows the horizontal map for Kirkuk's Qishla; b) – Qishla in 1918

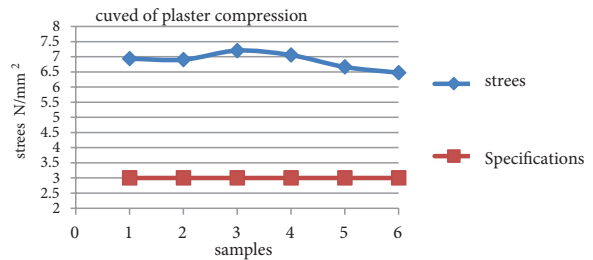
Figure 11. Curved compression plaster

Figure 11 shows that the results of the compressive analyses of plaster mortar were higher than the minimum determined by the Iraqi Standard for the Examination of Squeeze Plaster (IQS 27-1985) where the sample stress rate is equal to (6.87) N/mm² and the minimum stress specified by The Iraqi specifications is equal to (3) Newton/mm².

9.2.2. Compression check of Plaster as shown in Table 4 and Figure 11
